Prestige Home Inspection

Property Inspection Report

LOCATED AT:
2705 Oak Cliff Ln

INSPECTED ON:
Wednesday, June 27, 2018

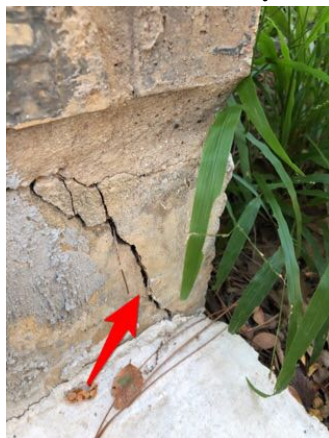
Corner spalds were noted in the foundation corners. These do not represent structural support problems and are generally cosmetic in nature. These areas should be monitored for further deterioration and pest control specialists notified of their locations as they can be locations of undetected insect entry.

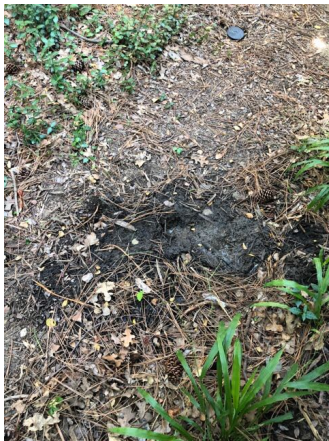
What appeared to be an underground leak was present at the rear left corner of the house. We recommend identifying the source of the leak and repairing it as necessary.

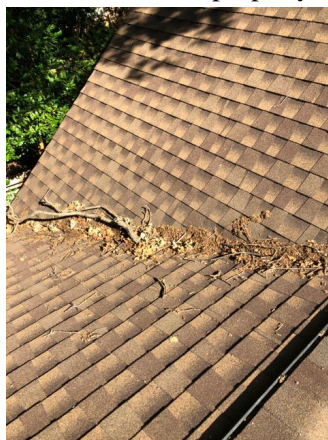
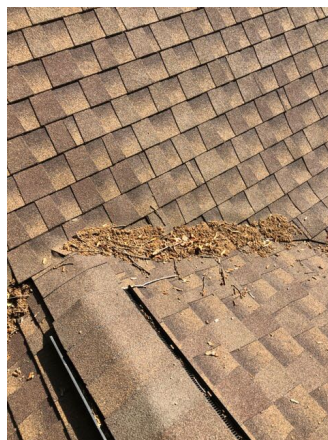
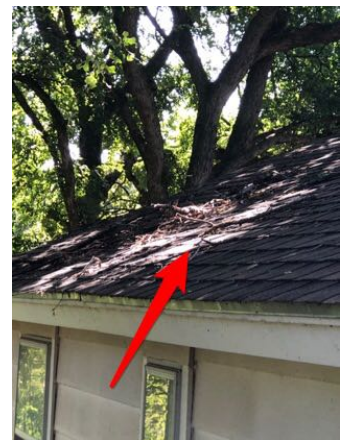
There is debris on the roof, requiring removal to prevent accelerated deterioration of the shingles. We recommend that the roof be monitored and periodically cleared of debris in the course of routine property maintenance.

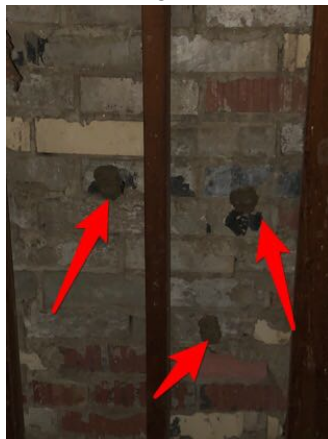
There is an active wasp nest in the attic. We recommend this nest be removed by a professional exterminator. Inspection was limited because of this condition. Keeping screens and vents in good condition will limit such infestation in the future.

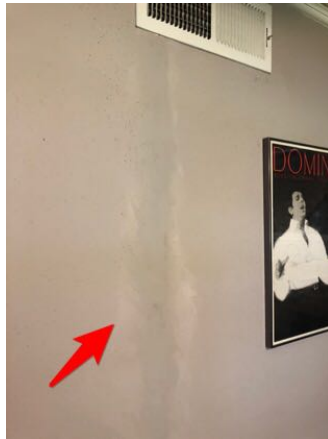
Previous repairs were noted at various locations of the house.

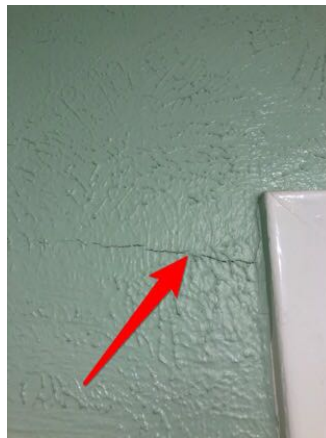
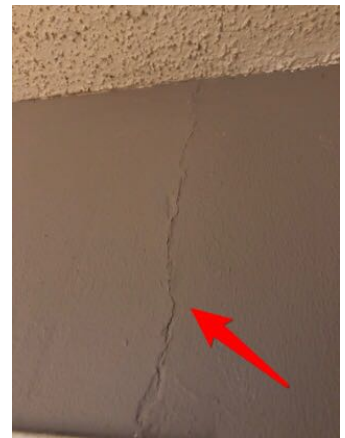
There are minor wall cracks. This type of cracking in this material is common and does not indicate a structural deficiency. These can be patched, prepared and finished in the course of routine maintenance.

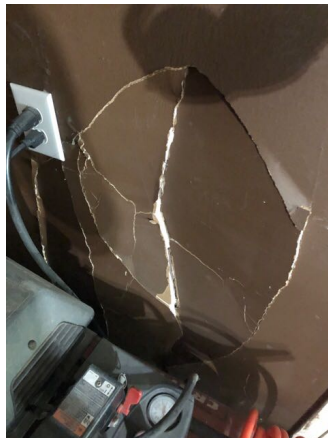
Garage rear wall

Impact fractures/holes were noted in the following locations: garage rear wall.

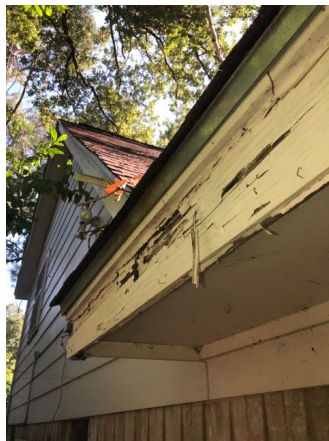
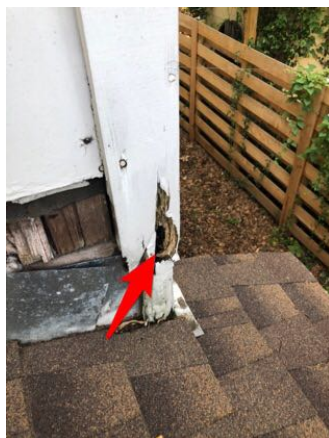
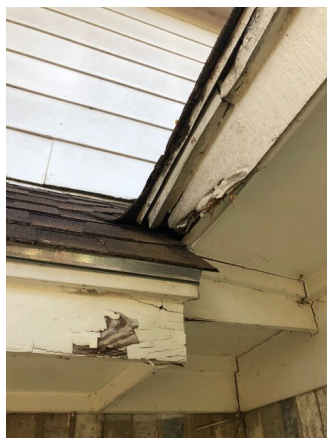
Soffit and associated trim damage was present in several areas around the exterior of the house. We recommend further evaluation and repair/replacement by a qualified professional.

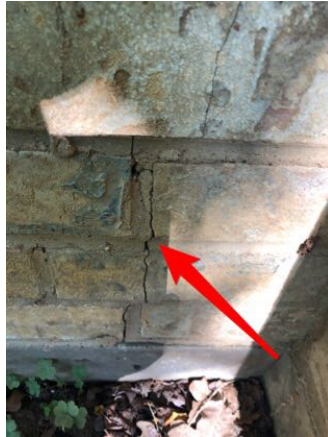
Some minor cracking of exterior walls was present at the time of inspection. Although these areas do not pose a structural problem at this time they should be monitored.

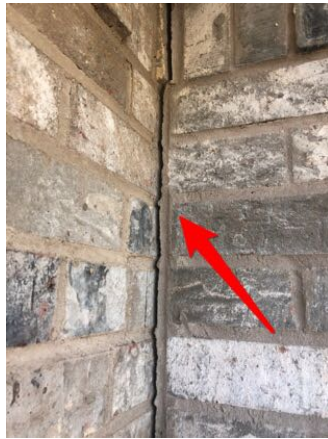
At back patio mortar joint

Moderate cracking was present along exterior walls indicating that some structural movement has occurred at some point in time. These areas should be repaired and monitored as a one time inspection cannot connect the amount of structural movement over time.

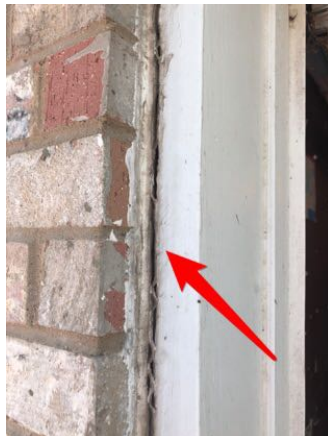
There was some garage door frameSeparation from exterior walls indicating that some structural movement has occurred at some point in the past.

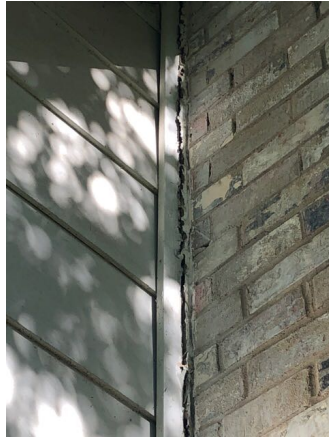
Chimney area

Trim separation from exterior walls was noted in some areas of indicating that some structural movement may have occurred in the past.

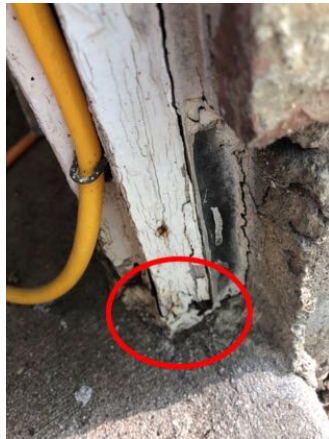
Garage trim

Wood rot along siding and/or trim was present along exterior areas of the house. We recommend repairs by a qualified professional.

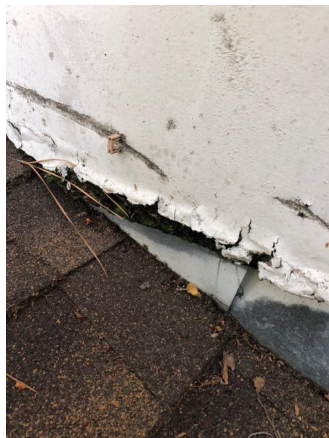
Above back porch

Sections of the hardboard siding are deteriorated. We recommend these sections be repaired or replaced.

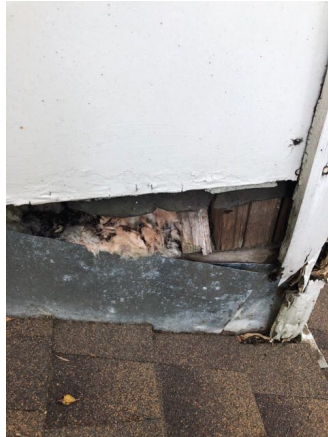
Above back porch

Sections of the hardboard siding are damaged. We recommend these sections be repaired or replaced.

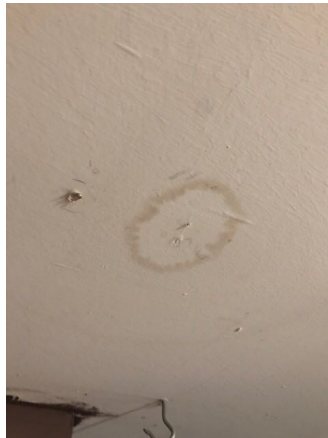
Garage

The ceiling is stained and was verified NOT WET with a moisture meter. The surface should be prepared and refinished to restore its appearance.

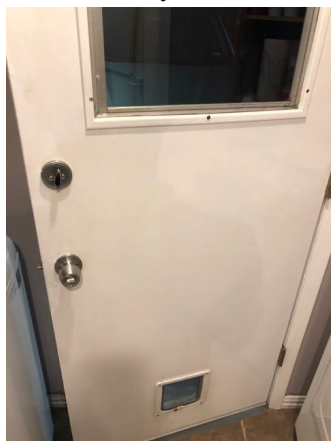
UPG The door between the house and garage should be a fire rated 20 minute, 1 3/8 inch solid core, or honeycomb steel door for the required dwelling/garage separation.

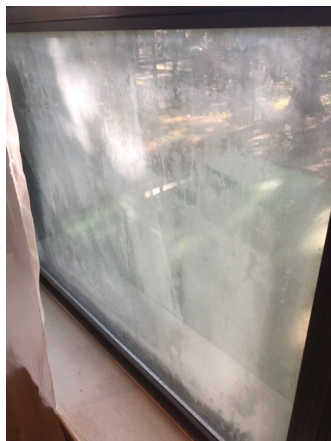
Dining room area

Thermal pane lost seal, window fogging and/or moisture was present in windows. This has resulted in condensation and/or residue developing between the panes of glass and can cause the glass to lose its insulating properties. Recommend contacting qualified window contractor for further evaluation and repair. Visibly fogged windows (NOT intended to be an exhaustive list) were noted AT LEAST at the following locations:

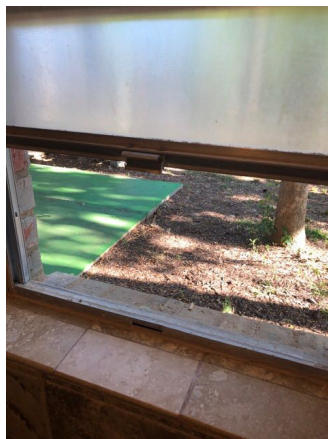
First floor bathroom

The screens for several of the windows are missing. We recommend they be replaced.

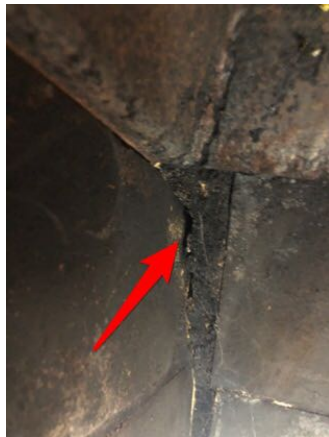
Upper left side

The firebox is damaged. We recommend it be repaired or replaced prior to any further use.

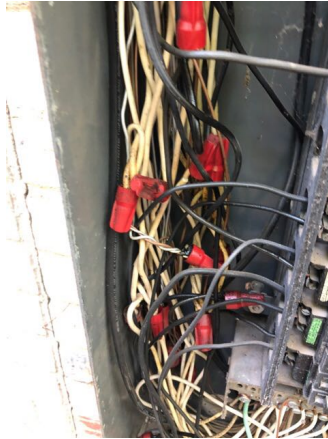
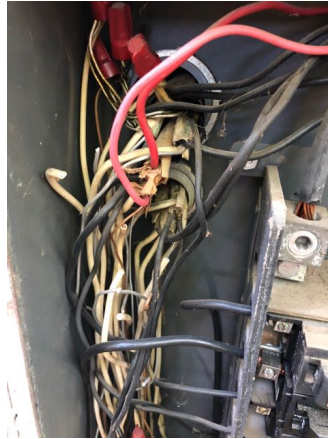
Many signs of non-professional workmanship were noted in this inspection. A licensed electrician should review the entire system and make all necessary corrections/modifications to bring the system into compliance with present industry standards.

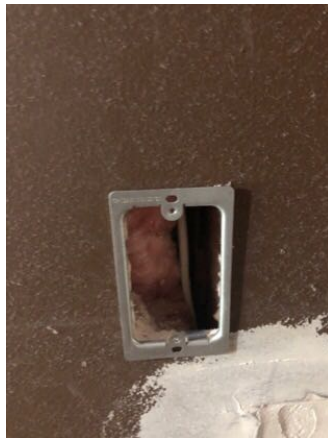
Garage rear wall

We found exposed wiring in this room. Even if insulated, we recommend all wiring be encased in a conduit or otherwise protected in accordance with present standards.

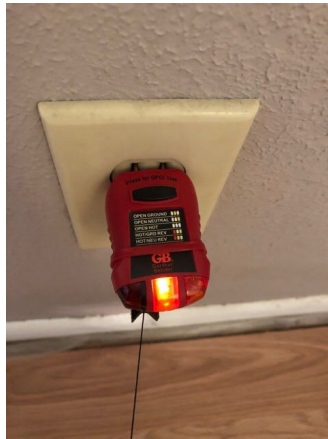
Second floor office

There are several ungrounded three prong receptacles in this area. We recommend they be properly grounded or restored to their original two prong configuration.

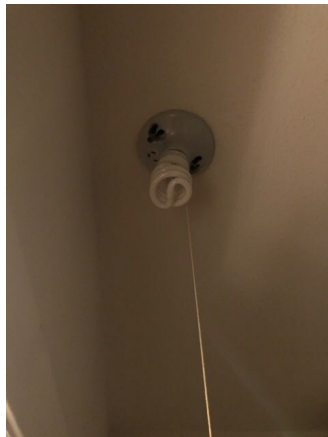
Various closet lights are not working. The bulb may have burned out. We recommend that the bulb be tested and replaced, if necessary, and the proper operation of the fixture be verified.

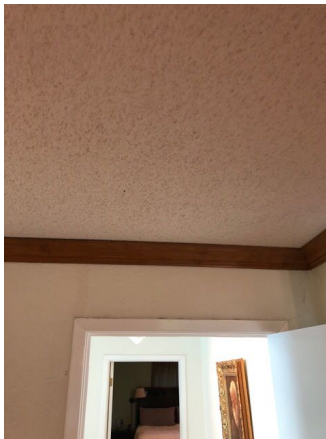
Smoke detectors failed to operate or were not properly installed in the following locations:

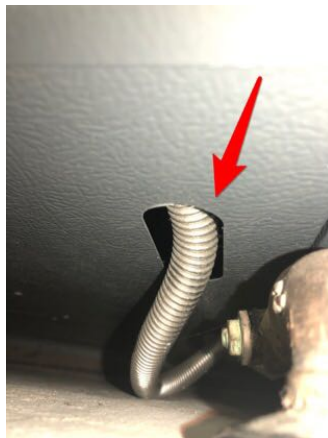
UPG A flexible gas line is currently being used to supply the furnace. Solid pipe is required to be utilized to prevent potential damage to the line. We recommend replacement of the flexible gas line with an approved solid line by a qualified professional.

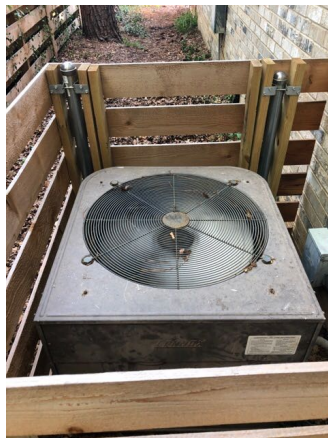
Condenser location: Left side of structure. The serial number of the unit could not be found at the time of inspection.

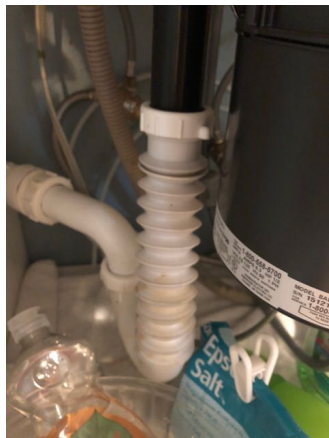
Under kitchen sink

Flexible drain lines are not allowed for permanent use. Flexible drain lines are designed for temporary repairs. Recommend contacting qualified plumber to replace with smooth walled plumbing as necessary.

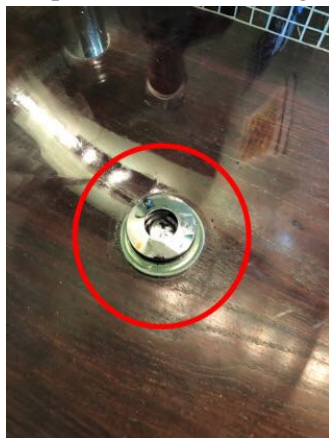
Second floor bathroom rear sink

Drop valves were missing or not operating as designed at time of inspection..

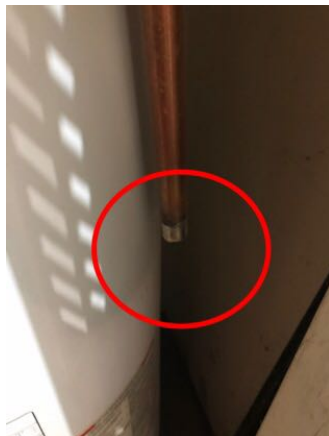
The temperature and pressure relief valve discharge pipe is not routed to an approved location. We recommend it be relocated.

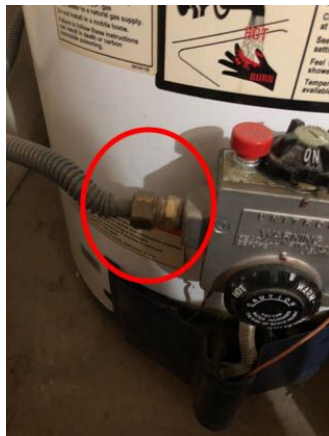
The fuel piping does not include a 'T' extension to collect condensation and debris, as is considered good practice. In the course of future upgrading or repair, a 'drip leg' should be added to the gas piping just ahead of the connector.

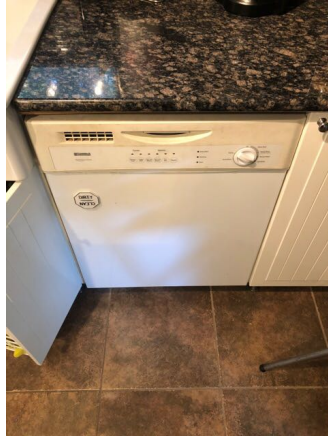
The discharge hose did not have an air gap at time of inspection. This is typically remedied by raising and attaching a loop to the bottom side of the countertop.

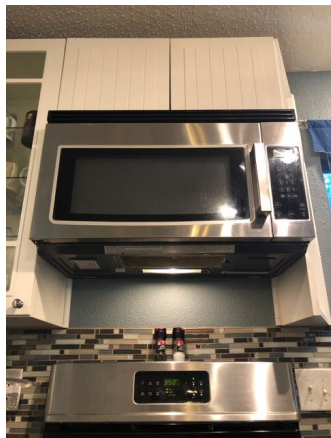
Kitchen ventilation is provided by a range hood over the stove. The fan appears to be properly installed and in serviceable condition. This fan does not vent to the exterior and has a filter which must be cleaned or replaced periodically.

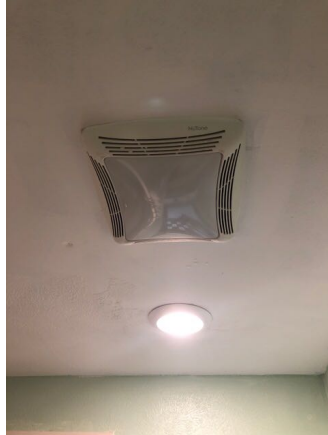
The duct from the second floor bathroom exhaust fan does not go to the exterior. This condition allows excessive moisture to be vented into the attic. We recommend this deficiency be corrected.

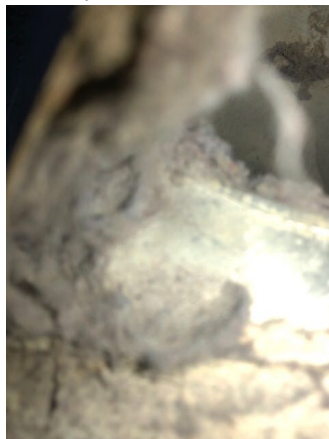
The dryer vent has accumulated dirt and debris. We recommend it be cleaned.
