Prestige Home Inspection

Property Inspection Report

LOCATED AT:
2705 Oak Cliff Ln

INSPECTED ON:
Wednesday, June 27, 2018

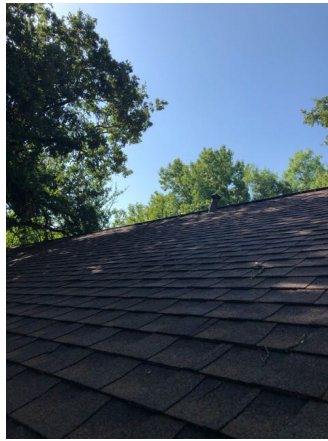
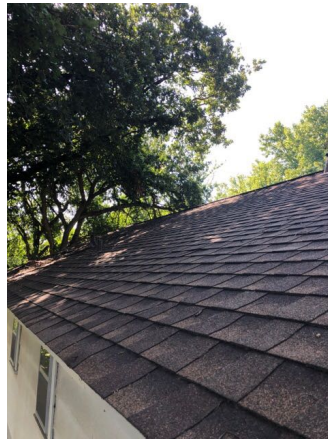
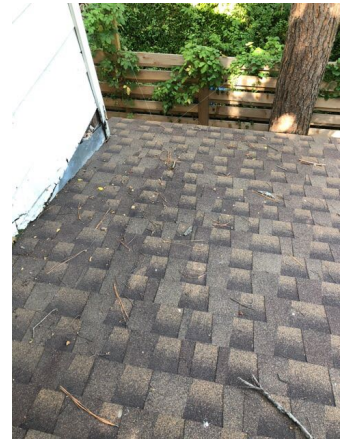
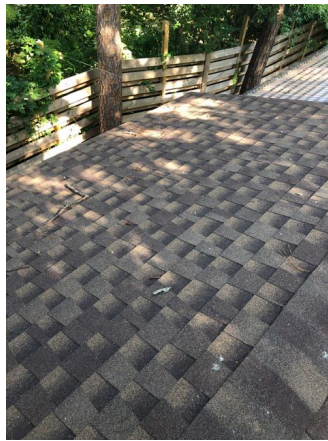
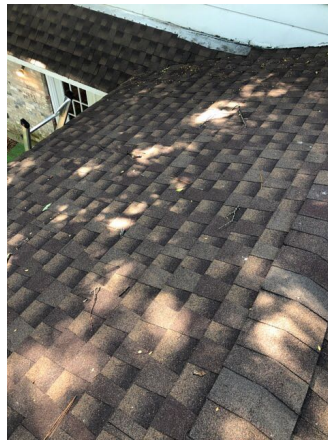
SURFACE

There is debris on the roof, requiring removal to prevent accelerated deterioration of the shingles. We recommend that the roof be monitored and periodically cleared of debris in the course of routine property maintenance.

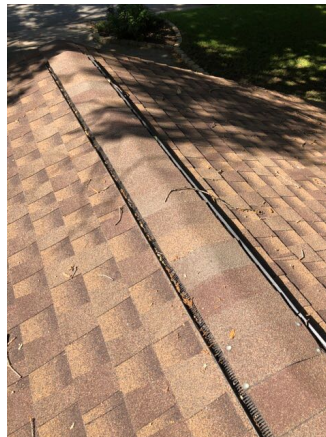
The attic is equipped with one or more thermostatically controlled automatic fans. These vent appeared abandoned at the time of inspection.

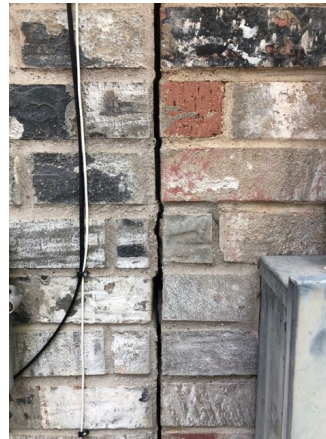
Left side of the house

There was some garage door frameSeparation from exterior walls indicating that some structural movement has occurred at some point in the past.

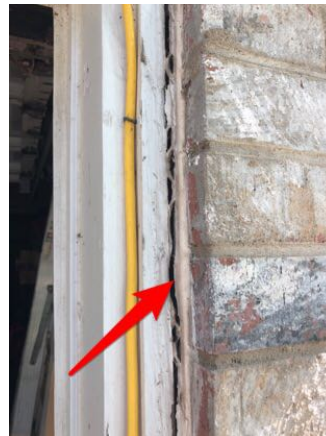
Trim separation from exterior walls was noted in some areas of indicating that some structural movement may have occurred in the past.

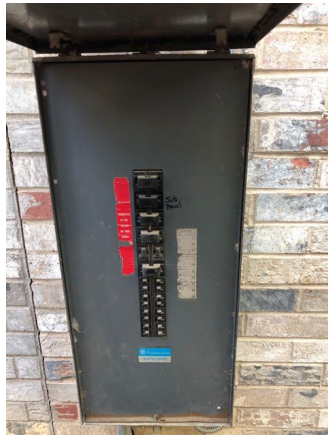
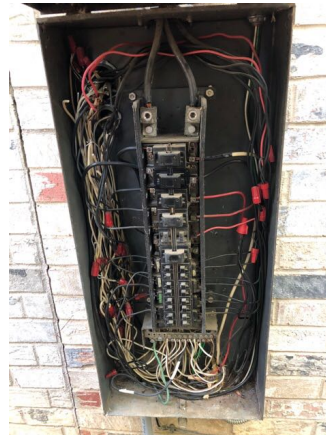
MAIN PANEL

The main electrical service panel is outside on the left side of the building.

Many signs of non-professional workmanship were noted in this inspection. A licensed electrician should review the entire system and make all necessary corrections/modifications to bring the system into compliance with present industry standards.

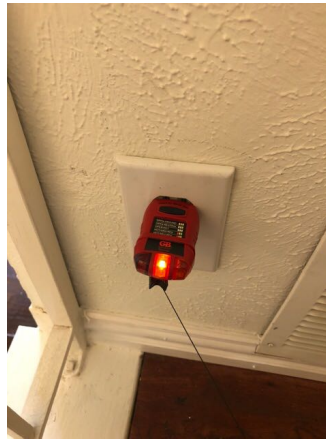
Second floor hallway

There are several ungrounded three prong receptacles in this area. We recommend they be properly grounded or restored to their original two prong configuration.

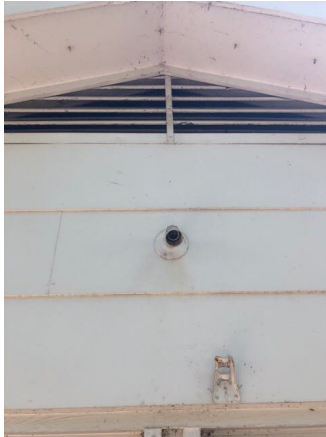
Front of garage

A light is not working. The bulb may have burned out. We recommend that the bulb be tested and replaced, if necessary, and the proper operation of the fixture be verified.

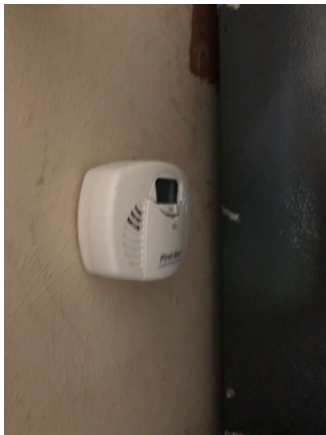
UPG Carbon Monoxide Detectors were present and operating as designed at time of inspection. We recommend additional detectors be placed outside sleeping areas.

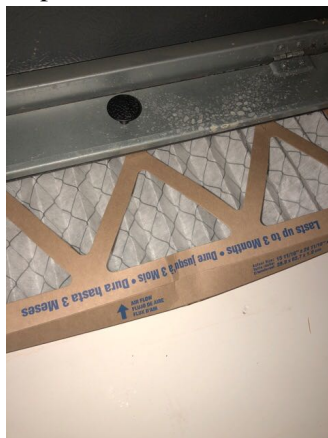
The air filter for the heating unit is a conventional, disposable filter and was clean at time of inspection.

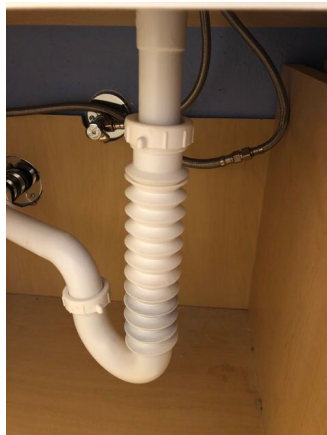
First floor bathroom

Flexible drain lines are not allowed for permanent use. Flexible drain lines are designed for temporary repairs. Recommend contacting qualified plumber to replace with smooth walled plumbing as necessary.

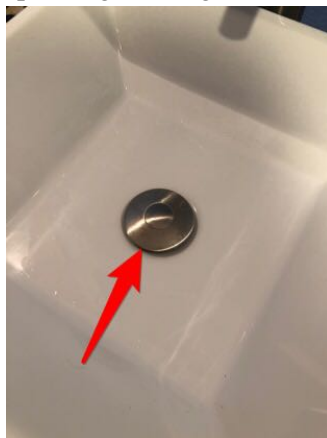
First floor bathroom sink

Drop valves were missing or not operating as designed at time of inspection..

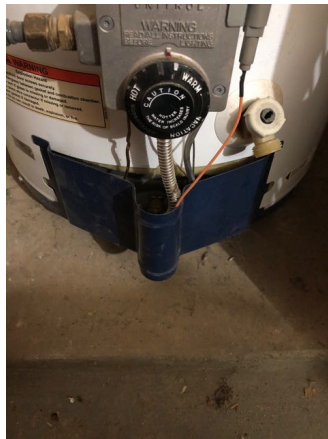
UPG There is no metal pan under the water heater to catch and divert any dripping water to the exterior. This is required by some jurisdictions for water heaters in this location. We suggest installation of such a pan be considered.

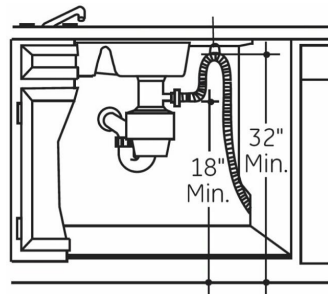
The discharge hose did not have an air gap at time of inspection. This is typically remedied by raising and attaching a loop to the bottom side of the countertop.

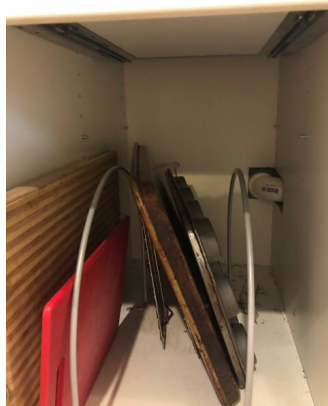
The gas shutoff valve is not accessible, as required by present standards. We recommend it be made accessible for convenient servicing and access in an emergency.

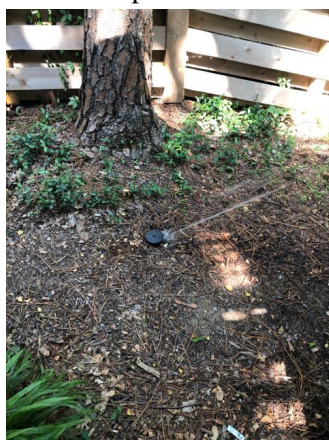
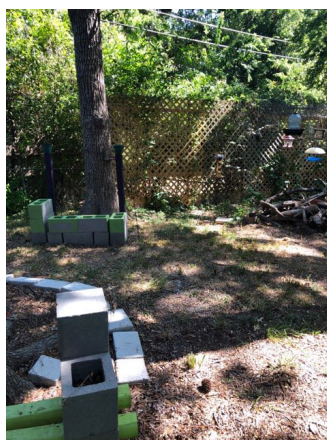
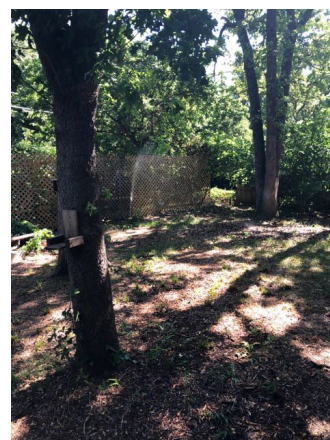
Operating sprinkler system pictures. The system operated by the control panel as designed at time of inspection.
